#15 Page 3 Power

Lot Layout and 1st floor

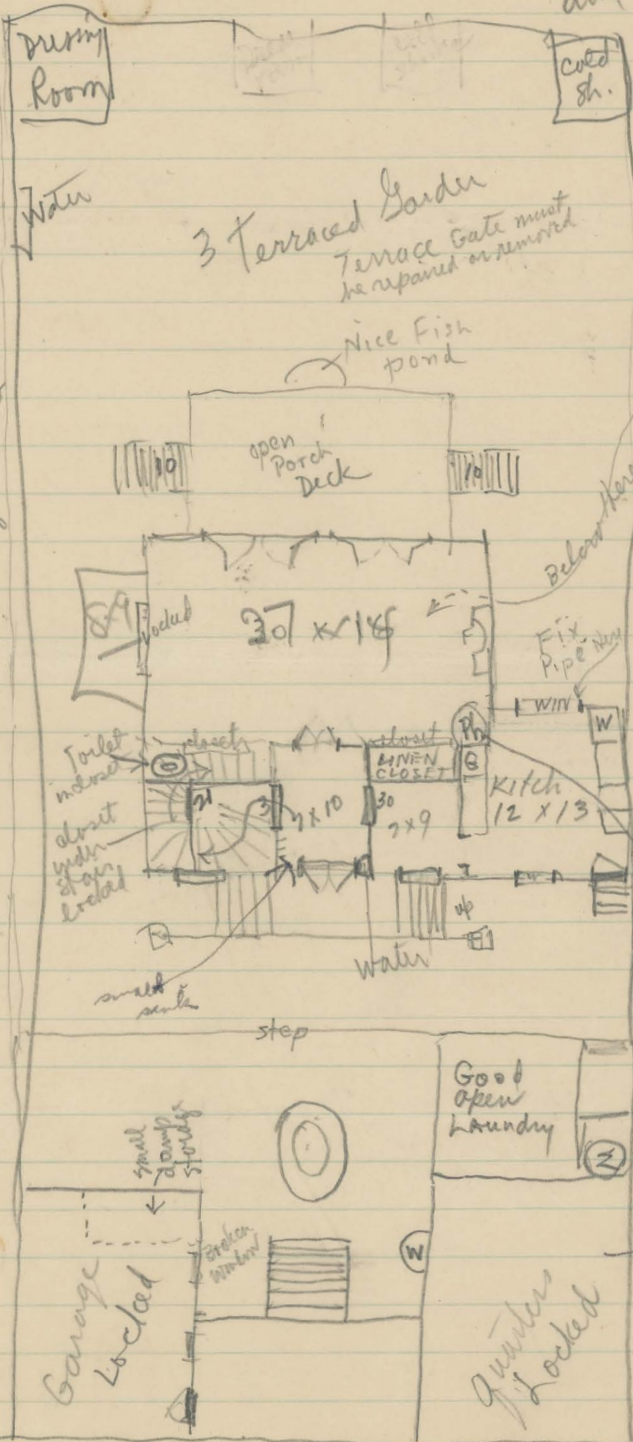
note looks in patches suggest infestation with rats

The linen closet on first floor about 8' x 10' x 2 1/2' ft. Has considerable storage space.

Kitchen has electric stove which works good. Storage cabinet

one can walk below either side of 1st floor to rear

Door small  
There is a large airy wine cellar 27 x 15 suitable for storage of all types of Hosp. Supplies - Floor Dressing sitting, House in ex-ellent Repair all Plumbing works.

about 11 x 24' outside door

each room downstairs - 1 electric outlet. Large rear room has 3,

2 spigots in kitchen downstairs, 1 in hallway

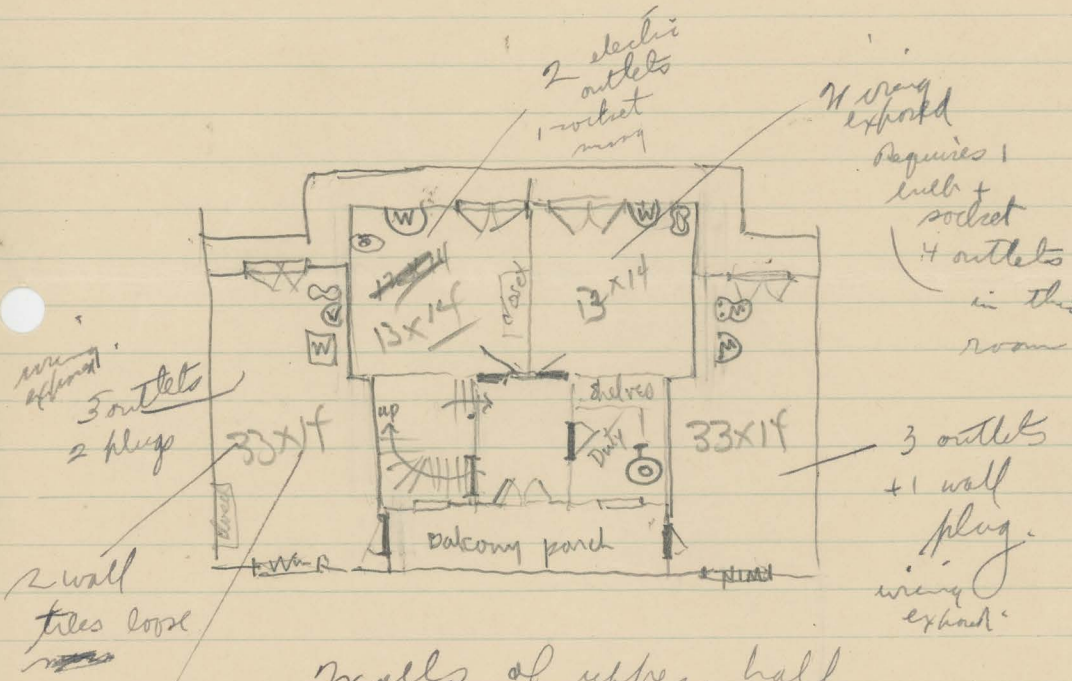
# #15 Plage Fleurie 2nd floor

Wiring exposed - possibly this is secret radio outfit. Moulding needed (20')

Wiring exposed in "duty" room

Walls of upper hall have deep cracks suggesting a sagging of floor.

2 sockets } missing  
2 bulbs } on 2nd floor

Wiring exposed in upper stair landing - will require 5 yd insulated wire and wood moulding to cover (30')

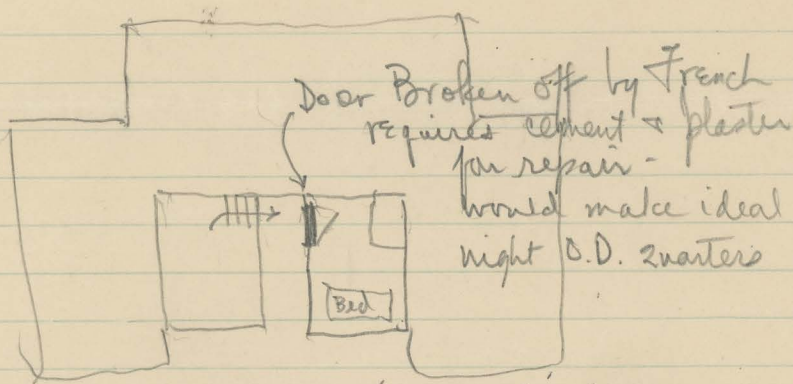
#15 Plage Fleuve Roof

Gravel Covered - No leaks  
Good condition

No electricity -  
There is some old  
wiring
